INSPECTION, MAINTENANCE & REPAIR OF PERMEABLE PAVEMENTS (Last Updated November 2017)

Permeable Interlocking Concrete Pavements (PICP) couple an attractive and functional pavement structure with a recognized low impact development (LID) stormwater management solution. However, it is important for owners to monitor the condition of these systems and rectify any signs of clogging or distress in order to ensure proper performance and fully optimize the pavement's lifespan.

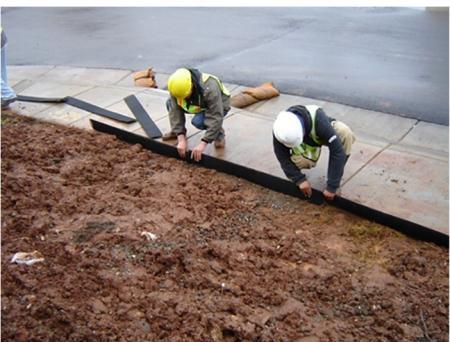
All areas expected to drain onto the PICP surface should either be grassed or paved (e.g. standard pavers, asphalt or concrete). Where bare soil or erosion gullies exist, silt fencing should be installed and maintained adjacent to the PICP surface. The objective is to prevent sediment laden stormwater from flowing onto and contaminating the PICP surface.

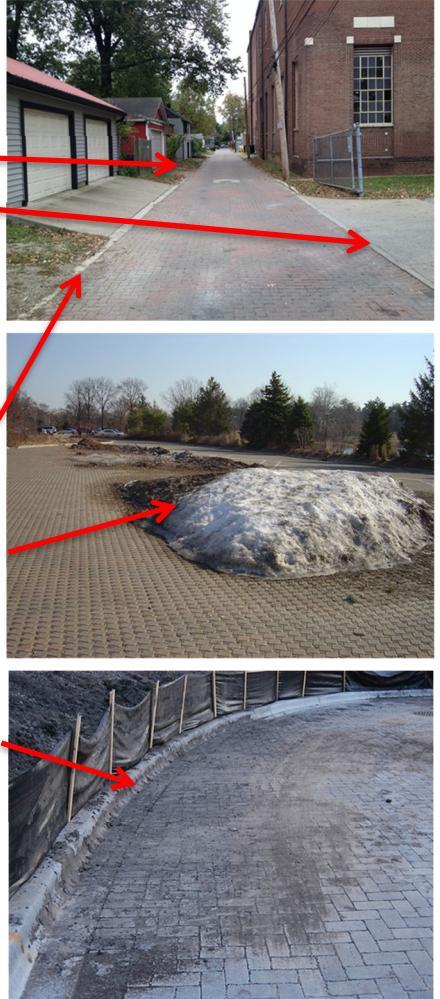
- Around trees. Leaves should not be allowed to accumulate long enough that they start to decay.
- Transition points from conventional (i.e. impermeable) drive surfaces. Sediment, including winter sand, can be tracked onto the PICP by vehicles, and will accumulate in the drive lanes and parking stalls.
- Surface water run-on areas. Any sediment contained in the run-on water will accumulate within the first few feet of the PICP pavement.
- Snow pile storage areas. The use of winter sand is discouraged. Do not store snow piles containing winter sand (when used), including snow from other impermeable surfaces, on the PICP surface.
- Adjacent to silt fencing. As previously mentioned, silt fencing is required between the PICP pavement and any bare soils or erosion gullies; inspect adjacent to the silt fencing to make sure it is working properly.

In the spring, the inspector should also look for accumulations of residual de-icing agents; some de-icing agents can chemically damage the pavers and should therefore be cleaned off as soon as possible.

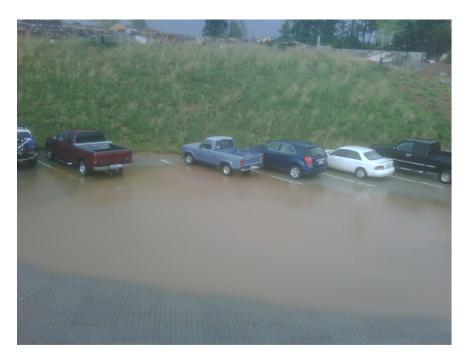
As mentioned previously, pavement surfaces can regularly be exposed to trash, wind-blown and tracked on dirt, and fallen leaves. Debris and sediment can accumulate in the joints which can impede, if not prevent, surface infiltration. Surface ponding is an indicator of clogged joints; vacuum sweeping as discussed in Section 2a, or possibly even remedial maintenance as discussed in Section 3g, may be required.

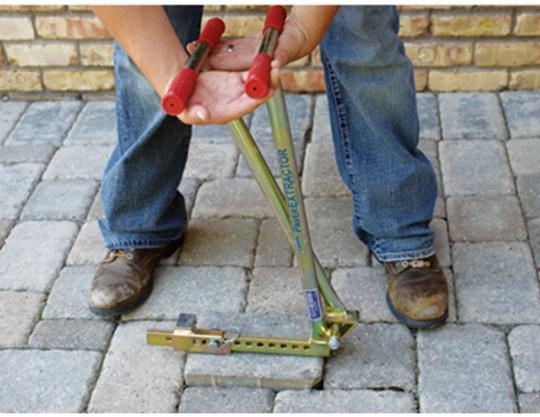
To remove a damaged paver(s), scrape out the jointing material around the first unit, then use a paver extractor (see adjacent) or couple of screwdrivers to pull the paver up. If this does not work, use a hammer and chisel to break up the first paver. Depending on the location of the paver, it may be easier to start at an outside edge and work your way towards the paver. Once you get the first one out, you can get under the other stones to pull them out, making the job much easier.

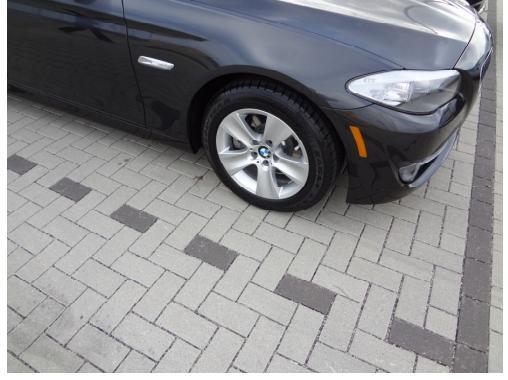
There are two ways of stripe marking a permeable interlocking concrete pavement – using different coloured pavers to create the markings (see adjacent), or painting the markings onto the pavement surface.

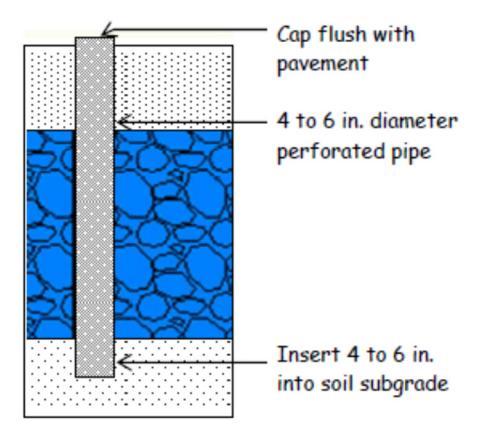
Water level measurements within the base and subbase. Depending on the type of PICP system (full-, partial- or no-exfiltration system), a monitoring well within the pavement field and/or outlet control device at the underdrain outlet would need to be included in the original Water levels can either be taken design. manually with a ruler or water level sensor, or automaticallv with а pressure sensing The purpose of the water level datalogger. measurements is to verify the system drains within the required post storm event time

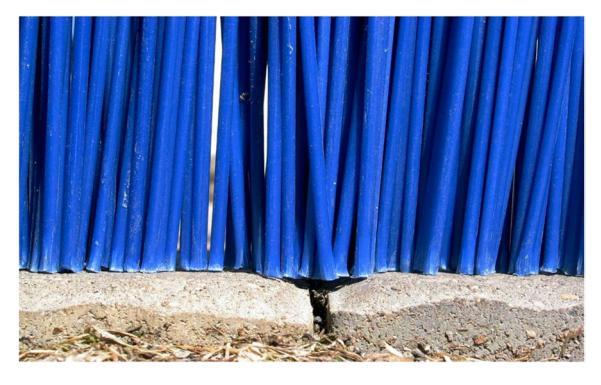
Brooming, including with hand brooms or mechanical broom sweepers, is discouraged – brooms tend to spread dirt around (which ultimately promotes clogging of a larger area), and are not successful at getting debris out from within the chamfer of the pavers (see adjacent). A chamfer is a 45 degree beveled edge around the top of a paver unit that helps prevent edge chipping, delineates the individual paving units, and provides a sloped outside edge in the event

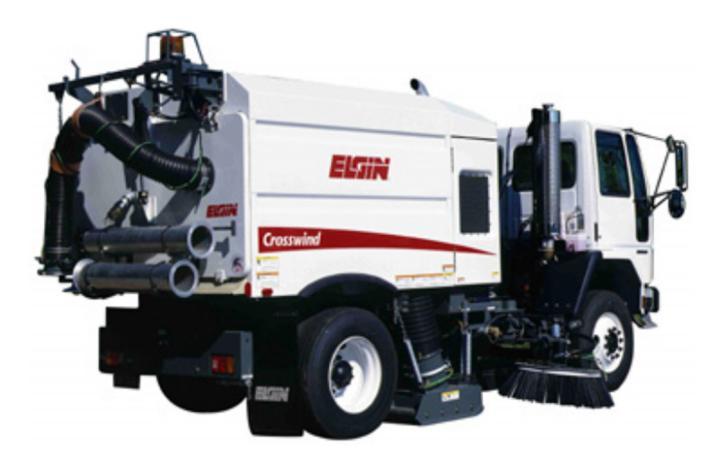
The recommended piece of equipment for regular cleaning is a shop vacuum for small areas, or regenerative air sweeper or similar (shown adjacent) for larger areas. Regenerative air sweepers use a blast of air the width of the sweeping head to dislodge material from the surface / joints, making it easier for the suction hose to pull up the debris and deposit it into the debris hopper. A regenerative air is not the same as a true vacuum sweeper (see Section 3g) as the amount of vacuum they produce is much lower.

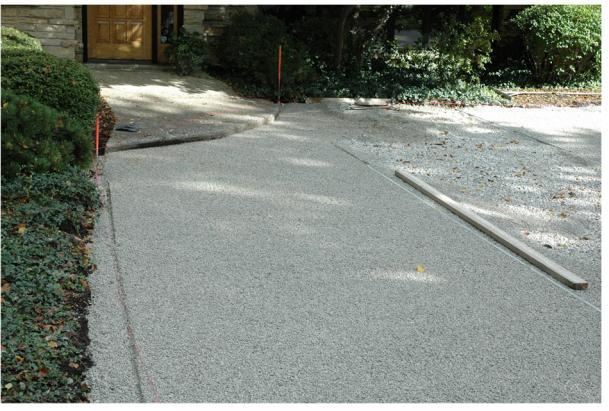
properly screeded (see adjacent) and remains uncompacted until final bedding of the pavers. The recommended method of installation is to layout the pavers on top of the uncompacted bedding layer, then use a vibratory plate compactor to seat them into the bedding layer; this way, height variances between adjacent pavers is adjusted for within the bedding layer and the final pavement surface ends up being level. When a contractors or pre compacts the bedding layer, the bedding

layer cannot compensate for any height variances in the pavers so lippage becomes evident on the pavement surface.

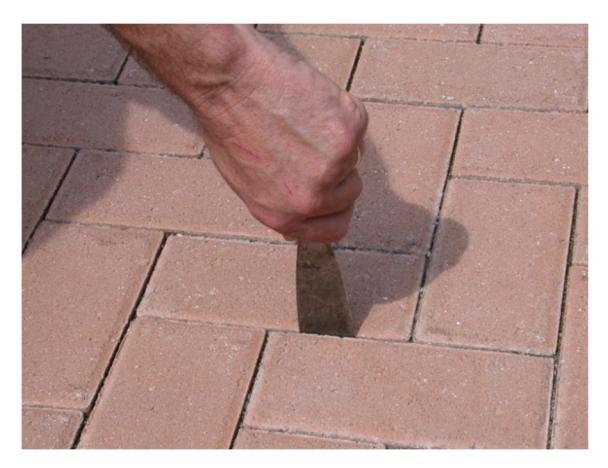
When first installed, jointing material should fill the entire joint to the bottom of the chamfer. However, as the pavement is trafficked, the jointing material can continue to consolidate within the joint (vibration causes the joint material particles to consolidate).

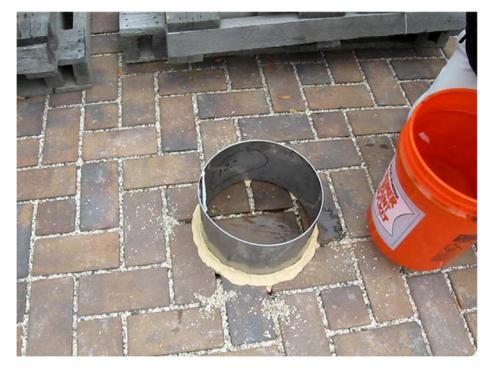
ASTM C1781 – Standard Test Method for Surface Infiltration Rate of Permeable Unit Pavement Systems was developed as an easily re-producible and low cost method of monitoring the performance of PICP. The test method requires a 12" diameter plastic or metal ring, plumber's putty, a 20 litre pail, and a stop watch. The ring is seated onto the pavement surface using the plumber's putty. Water is slowly poured into the ring such that 10 to 15 mm of water head is maintained above the pavement. The time taken for the entire

contents to drain is measured. An equation within the standard is used to convert the time into an infiltration rate expressed in mm per hour.

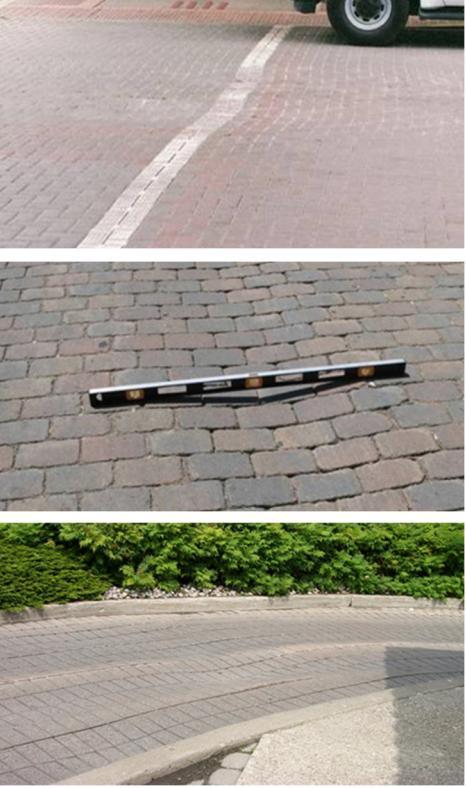
With conventional pavements, depressions or ruts are typically identified by surface water ponding, but given that PICP are permeable surface ponding may not be present. Shadows and colour changes are also viewed as evidence of depressions, but actually can give the impression of differential settlement where none exists. It is always best to lay a 3 m long straight edge on the

surface and measure any height variances along the length – elevation changes should not exceed 13mm. Rather than try to use a ruler to measure the variance, find a 12mm diameter rod (dowels are available at most hardware stores) and try to slide it under the straightedge when it is laying flat.

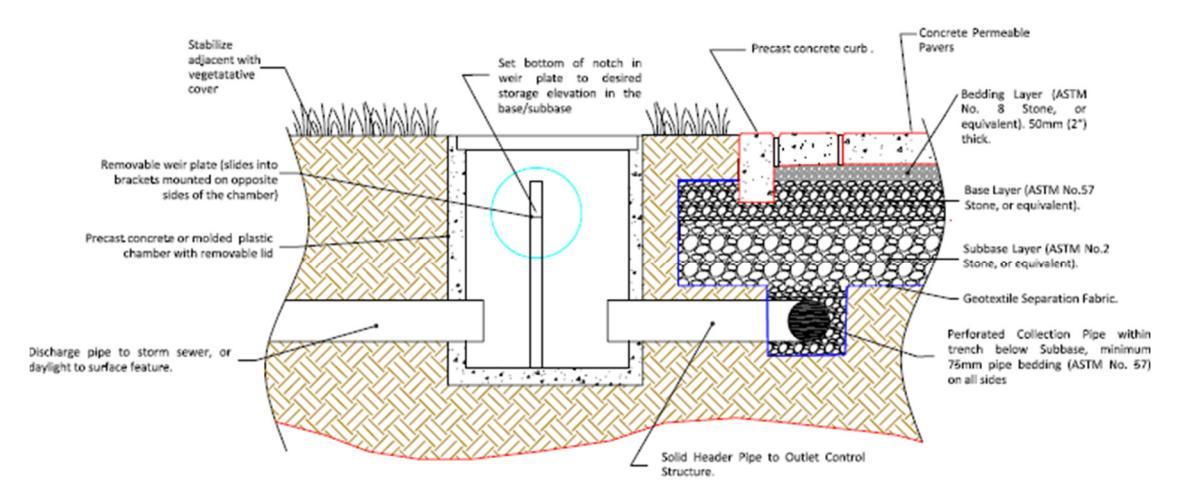
With underground utility connections, we recommend a monitoring vault be installed where the underdrain extends beyond the PICP boundaries (see below). The water storage volume of the PICP system (and in turn the time required for the system to drain) can be adjusted by modifying the weir plate notch elevation. The chamber also provides a convenient location for water quality sampling and quantity measurements.

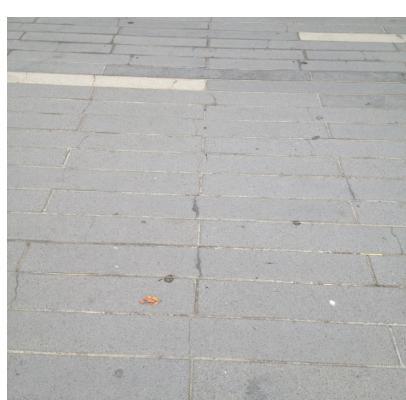
Visible Cracks: Visible cracks that extend across the entire unit are evidence of damage due to product overloading or poor installation practices. For example, the pavers in the adjacent photo were initially selected based on their suitable for a pedestrian walkway; unfortunately the designer neglected to consider the fact that maintenance vehicles would drive over the pavers, and the pavers cracked under load.

evaluate whether (A) the existing pavers should be replaced with a different product that is suitable for the expected traffic loading, (B) consider an alternate design approach (pervious concrete overlay) that would provide greater flexural support to the existing pavers, or (C) install measures to prevent vehicles from accessing the area (e.g. bollards).

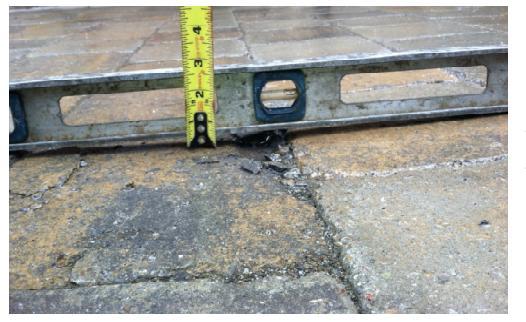
Edge Chipping: For pavers with nominal to no chamfers (see adjacent), chipping along the outside edge of the pavers can occur (especially when installed tightly together). As traffic drives over the pavement, the pavement flexes and the outside edges of the pavers can come into contact with one another; the resulting pressure between units can pop edges off one or both of the paver faces. If the problem is wide spread or persists, the owner can consider having the

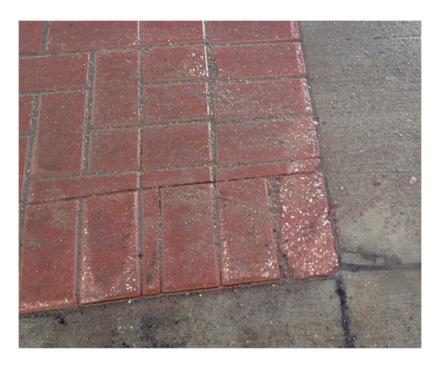
Surface Spalling: Spalling of the paver surface (adjacent) occurs when something like a snow plow strikes an exposed outside edge of the unit and shears off a section of the face. This only occurs when the paver(s) is elevated above the adjacent surface, which can be a result of poor installation or settlement/frost heave. In the case of poor installation, the pavers would need to be lifted and relayed. To assess settlement or frost heave, refer to Sections 3b to 3d for more details.

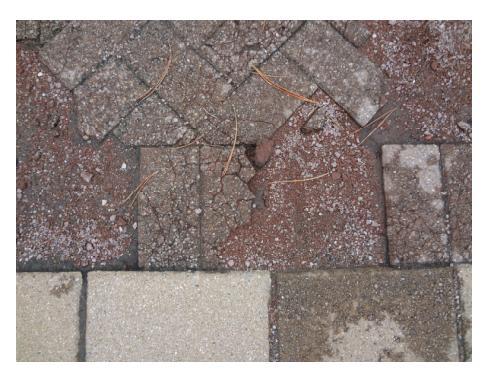
Deterioration: Deterioration of the paver (adjacent) is indicative of chemical damage from de-icing chemicals; magnesium based de-icers in particular are problematic in that the magnesium chemically degrades the cement paste. The owner should discontinue the use of these deicing chemicals, or at minimum switch to a sodium chloride deicing agent which is not as harmful to the product.

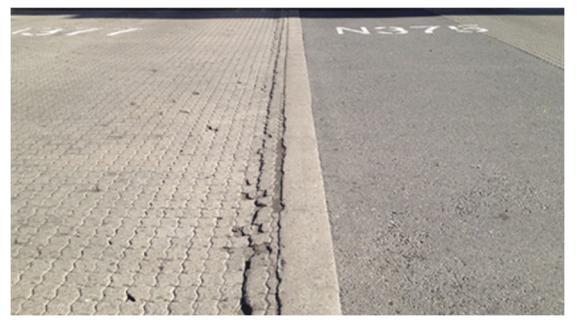
Deterioration of pavers adjacent to road features such as concrete edge restraints (see adjacent), catch basins or manholes is due to settlement of the underlying base and subbase materials. Proper compaction in these areas during installation requires extra effort to achieve, and therefore may not have been accomplished. As the material and pavers settle, the pavers separate and the joint material gets washed out.

Once this occurs, vehicles trafficking the area will cause the pavers to knock together breaking them apart. The pavers would need to be lifted, the base and subbase properly compacted, then the pavers reinstated.

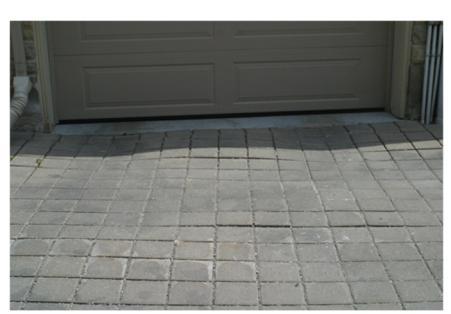
The adjacent photo is from a PICP installation where traditional bedding sand and Granular A, rather than the specified open graded materials, where used. The low infiltration rates of Granular A caused the bedding sand to remain saturated for extended periods of time; the smaller particles in the sand became suspended and, as vehicles drove over the area the slurry was displaced. The wash out of bedding material resulted is settlement in the vehicle

tracks. Again, to verify this is in fact the case, follow the same procedure above; the presence of small particles suspended in water, forming a slurry, would be evidence of improper base material (where the proper base material present, any fines would have migrated downwards).

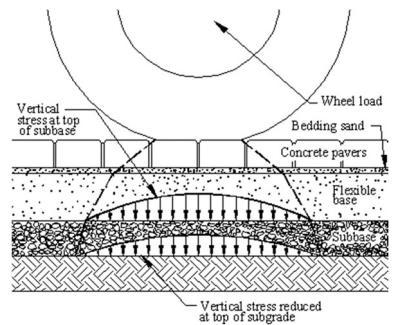
• The depth of the aggregate base is insufficient for the given traffic conditions (the deeper the aggregate base, the higher the stress reduction on the subgrade – see adjacent), and the subgrade starts to break down and/or consolidate. In this case, a more comprehensive review of the original design details and overall reconstruction is required. Consult with the original designer, or other appropriate professional, to assess the situation before proceeding.

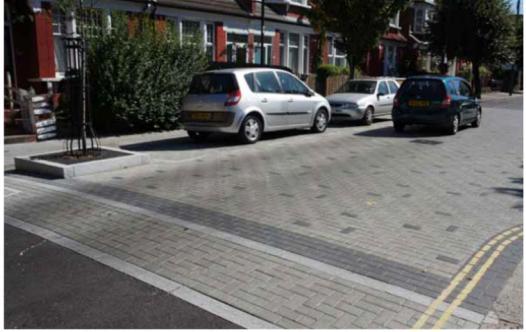
sense of direction; unfortunately running bond has limited interlock. The options are to change the laying pattern (herringbone is preferred), or install header curbs on each side of

the crosswalk (shown adjacent) to help secure the pavers in place.

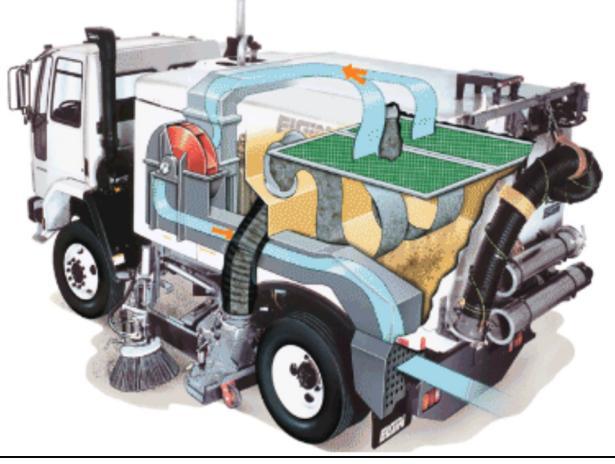
To perform remedial maintenance on a PICP surface, a true vacuum truck is required (Elgin Whirlwind shown adjacent or equivalent). The vacuum nozzle (36" x 6" just in front of the rear tires) allows for concentrated suction on a small area of the pavement, which is needed to remove the sediment from between the joints. The

nozzle rides on castor wheels so it will not damage the pavement surface.

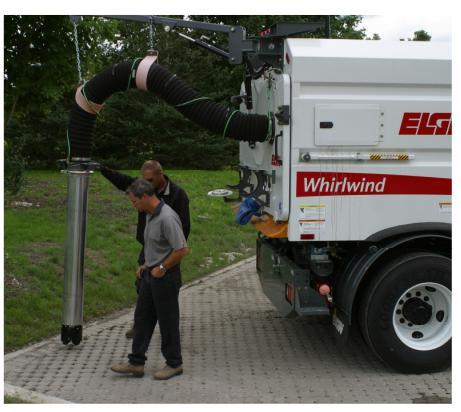
For particularly difficult (sediment has become embedded into the joints) or hard to reach areas, the rear mounted wandering hose (typically used for catch basin cleaning) can be used as shown in the adjacent photo.
