Interlocking Concrete  
Pavement Institute®

## Your requested ICPI Tech Spec **07** follows this page.

## Repair of Utility Cuts Within Interlocking Concrete Pavements

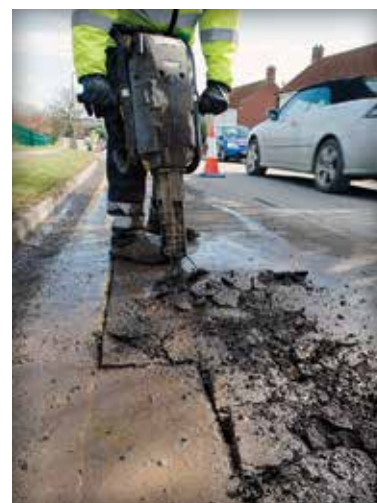
Figure 1. Repairs to utilities are a common sight in cities, incurring costs to cities and taxpayers.

North American cities have thousands of utility cuts made in their streets each year. Figure 1 shows a daily occurrence in most cities: repairs to underground utility lines for water, sewer, gas, electric, steam, phone, fiber-optic, or cable services. A sample is given below of the number of annual utility cuts in a few cities.

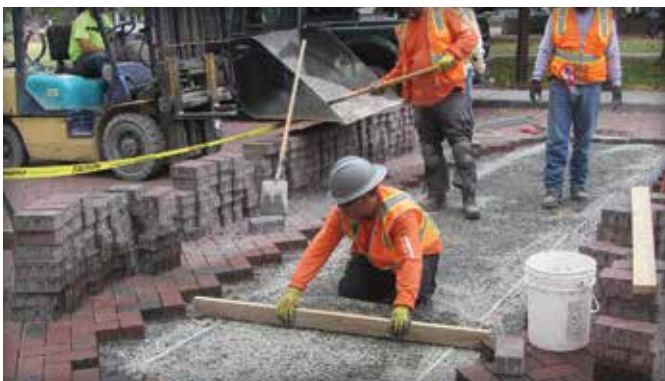
Figure 2. After compaction of the base, bedding material is screeded.

Figures 2, 3, 4, 5 and 6 show the process of repair and illustrate the continuity of the paver surface after it is completed. The

**Bedding sand** can be installed when the concrete is firm enough to walk on, generally within a few hours after placement. The bedding sand should be as hard as available and should conform to the grading requirements of ASTM C33 (11) or CSA A23.1 (10). *Mason sand, limestone screenings or stone dust should not be used.* The sand should be moist, but not saturated or frozen. Screed the bedding with 1 in. (25 mm) diameter screed pipe. Remove excess sand from the opening.

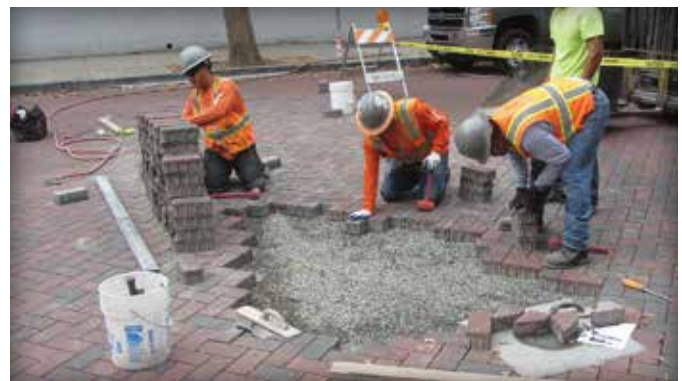
Figure 3. Once smoothed and joined with undisturbed materials at the opening perimeter, the bedding receives concrete pavers.

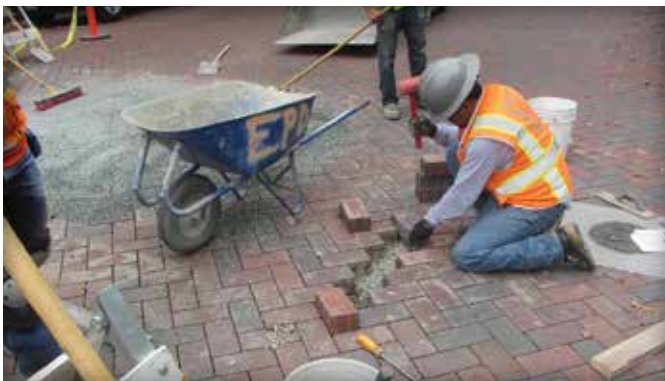
Figure 4. Reinstatement using the same pavers continues following the existing herringbone paving pattern.

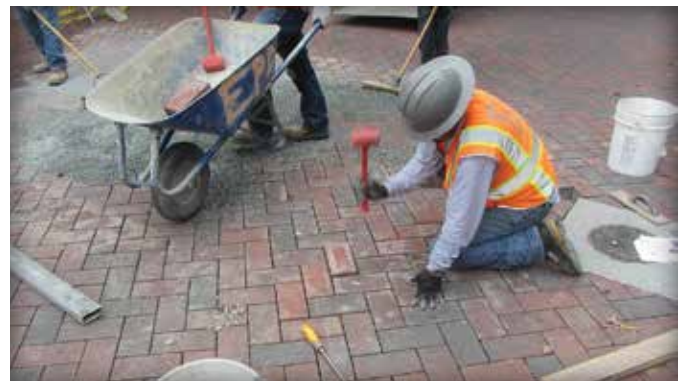
Figure 5. The final paver is inserted, the reinstated area compacted, joints filled, and compacted again. There are not cuts or damage to the pavement surface.

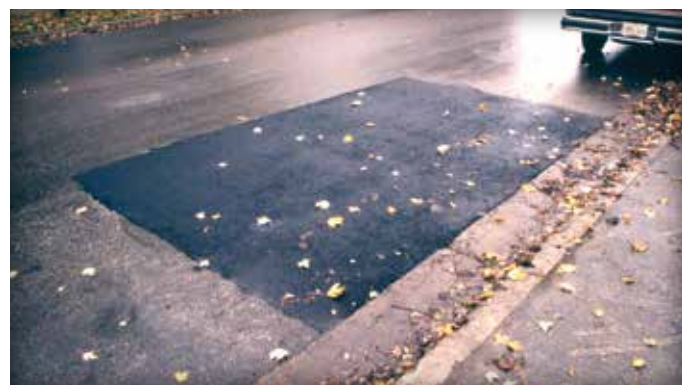
Figure 7. Pavement damage from settlement and shrinkage of cold patch asphalt.

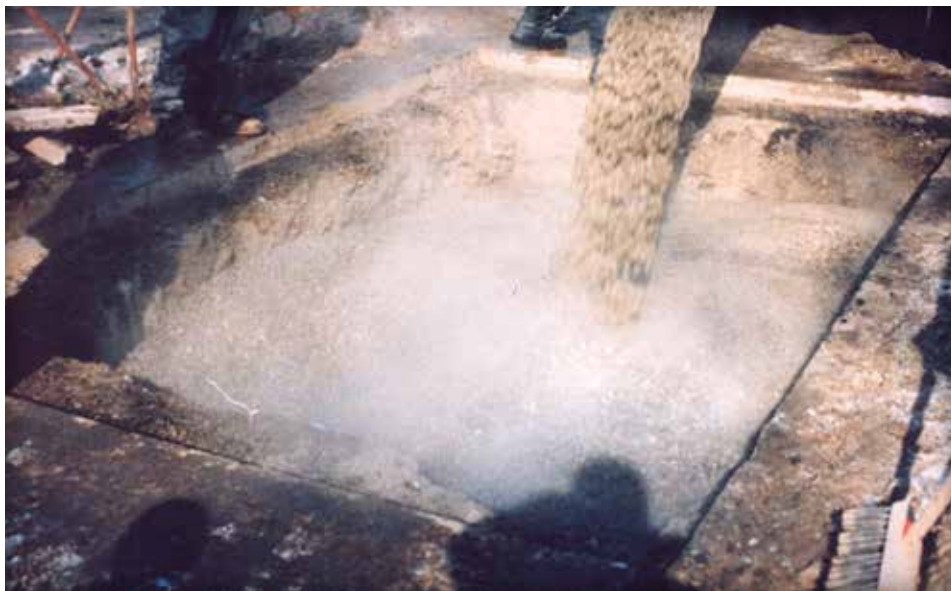
Figure 8. Low density concrete fill (unshrinkable fill) poured into a utility trench from a ready-mix concrete truck.

**Unshrinkable fill** poured into a trench is shown in Figure 8. The fill flows into undercuts providing additional support, and in places where the soil or base has fallen from the sides of the trench. These places are normally impossible to completely fill and compact with aggregate base or backfill material.

There are many mixes used for low-density concrete fill (7)(8). Proprietary mixtures include those made with fly-ash that harden rapidly. Others are made with cement. A recommended mix can be made with ASTM C150 (9) Type I Portland cement (or Type 3 for winter repairs), or CAN3-A23.5-M type 10 (or type 30 Portland cement) (10). The slump of the concrete should be between
